ROOF CONDITION REPORT

St Anns Quay
Quayside
Newcastle upon Tyne
NE1 3BB

28th November 2018

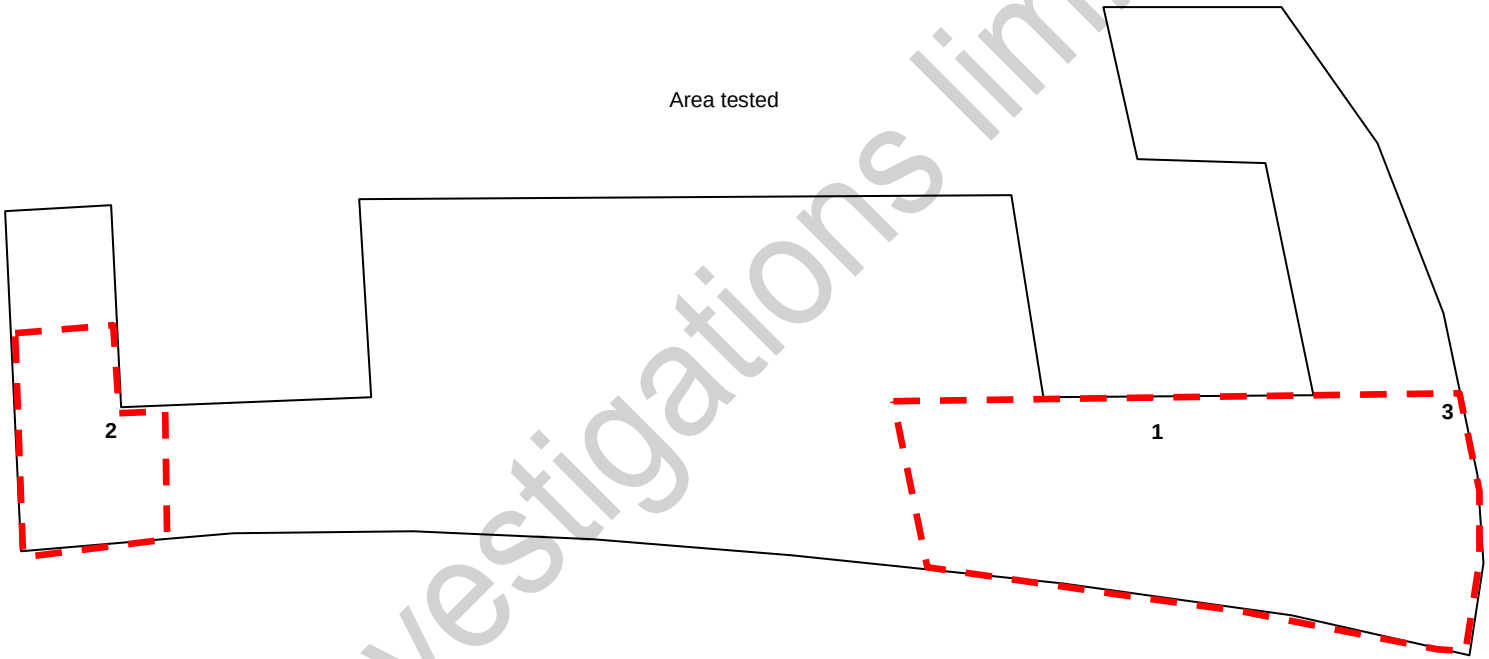
Defects

The ELD and visual survey identified a total of 3no. defects to the roof area.

Defect No.	Description of defect found at site
1	Upstand termination not sealed
	Failed weld
